## Rapid AS4349.3 TPI

**Property Address:** 23 Anywhere Street Anywhere

Job Number 4567 Property Address 23 Anywhere Street Anywhere

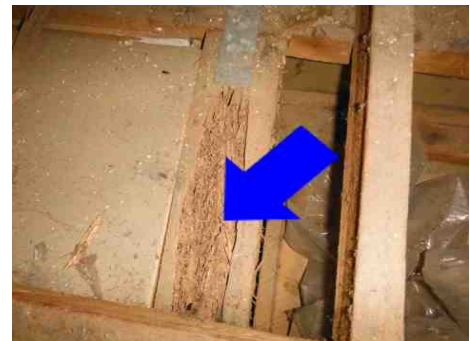
Were termite workings present at the time of the inspection?

**YES**

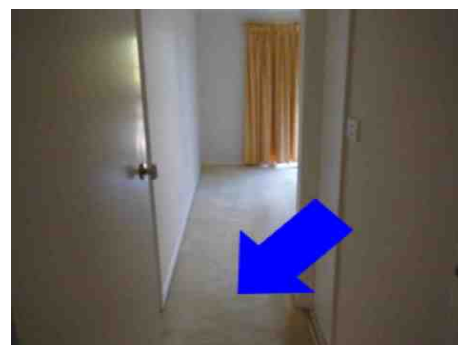
#### Entrance Hallway

High moisture readings can be caused by any one of the following: poor ventilation, ineffective drainage, leaking pipes, leaking roofs, defective flashing or by concealed termite activity. The areas of high moisture should be investigated by way of an invasive inspection. If high moisture was reported then you must have a building expert investigate the moisture and its cause and determine the full extent of damage and the estimated cost of repairs.

High moisture readings were evident to the following areas...

Floor Areas

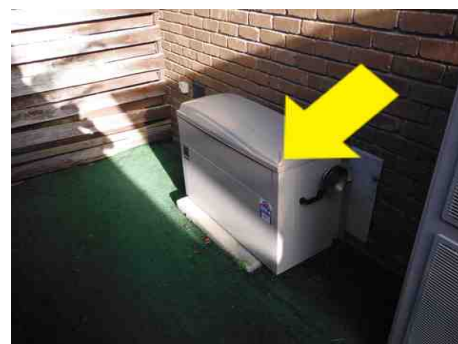
#### APPLIANCES RESTRICTED ACCESS

Appliances restricted access to various areas externally such as, heaters, air-conditioners etc.

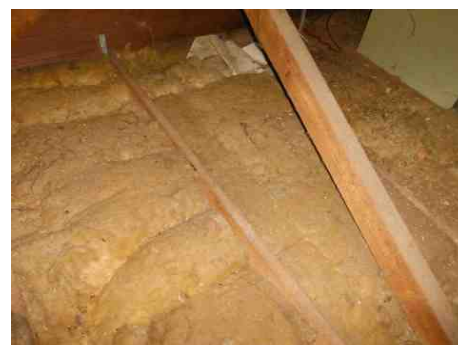
#### Insulation

Insulation prevented visual access to roof void areas.

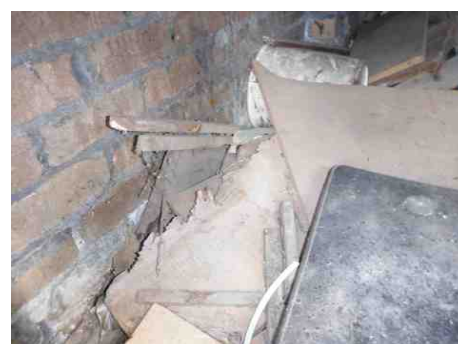
#### Stored Items

Stored items restricted access to various areas internally.

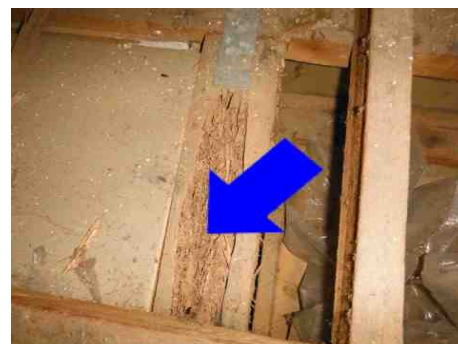
#### **Top Plates**

**Yes: Termite Workings were evident**

#### **Roof Void**

The degree of damage appeared to be moderate to severe. Further assessment by a builder or structural engineer prior to purchase recommended.

It is highly recommended that you have a termite treatment carried out on the property. Invasive inspections prior to purchase are recommended.
